Date Inspected:
12/08/2016

Asbestos Design Data Collection (DDC)

Name of Building: Franklin Learning Center

Address: 616 N 15th St. Philadelphia, PA 19130

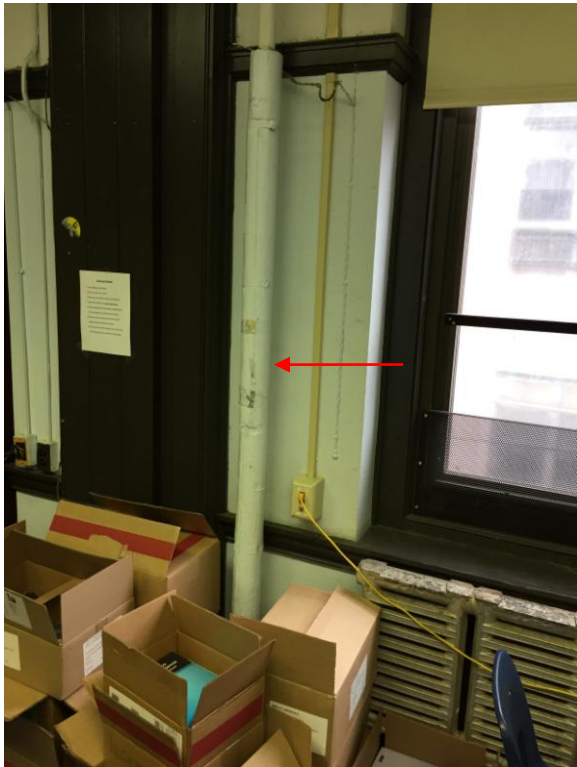
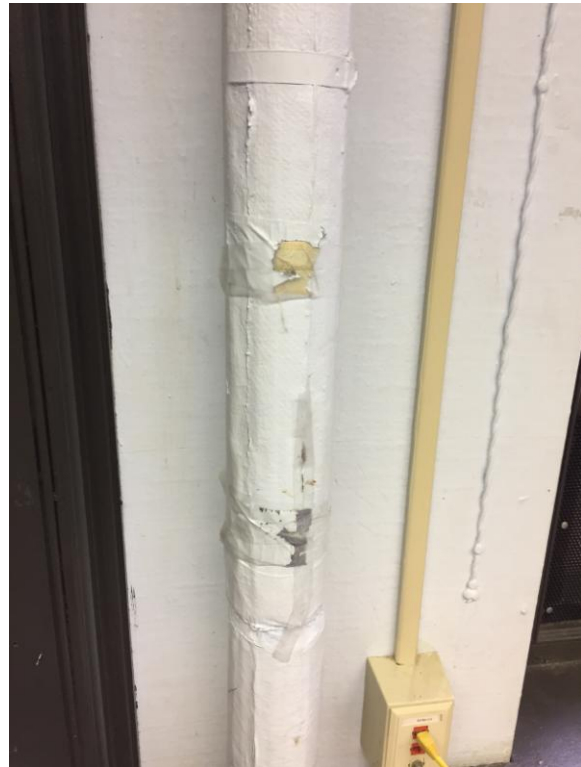
IMC 221

Remove 7 LF of damaged ACPI (riser beside left hand window) - Minor Project
Outer lagging is ripped, torn, repaired with scotch tape - exposed end at bottom

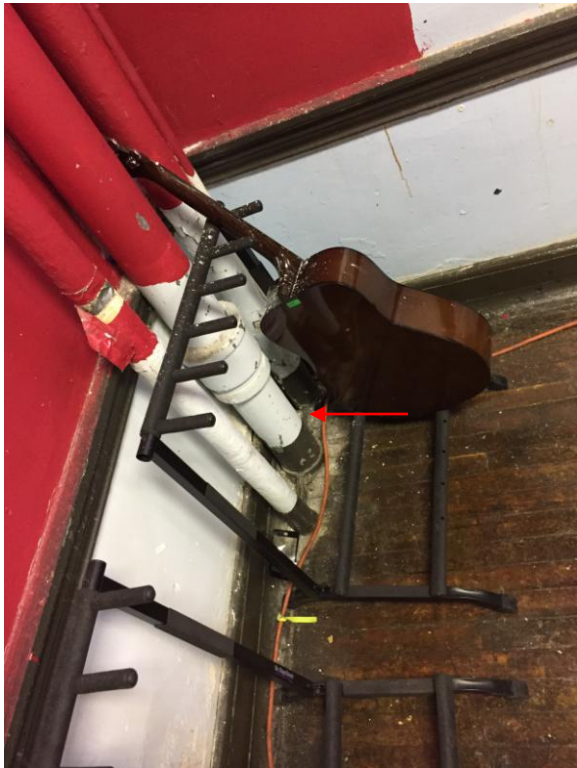
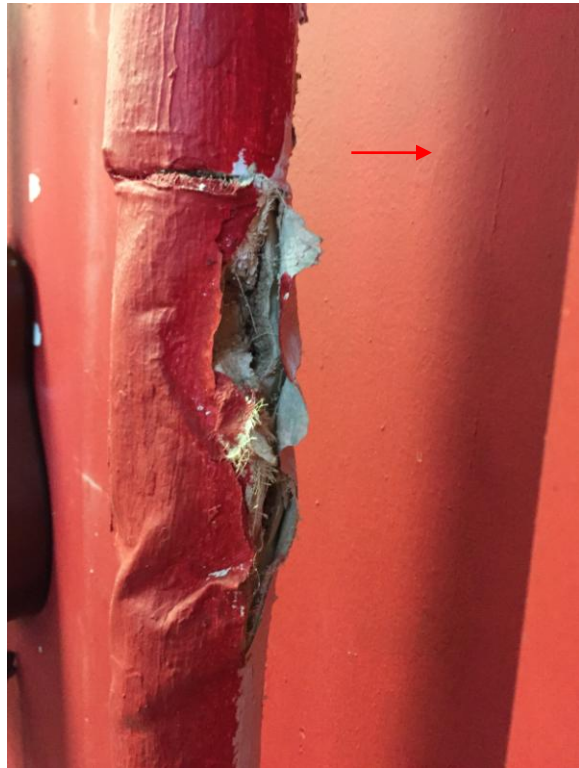
133 – Music Classroom 133
Remove 14 LF of damaged ACPI (riser beside left hand rear corner) - Minor Project
Outer lagging is ripped and torn

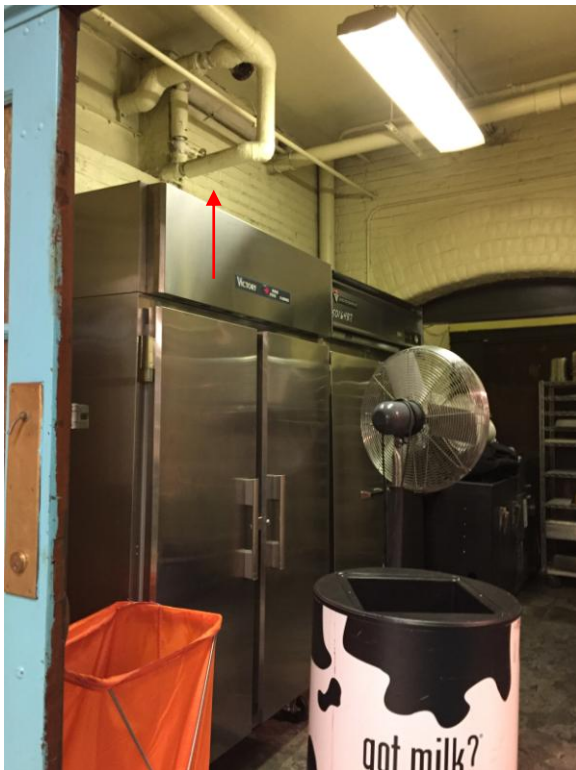
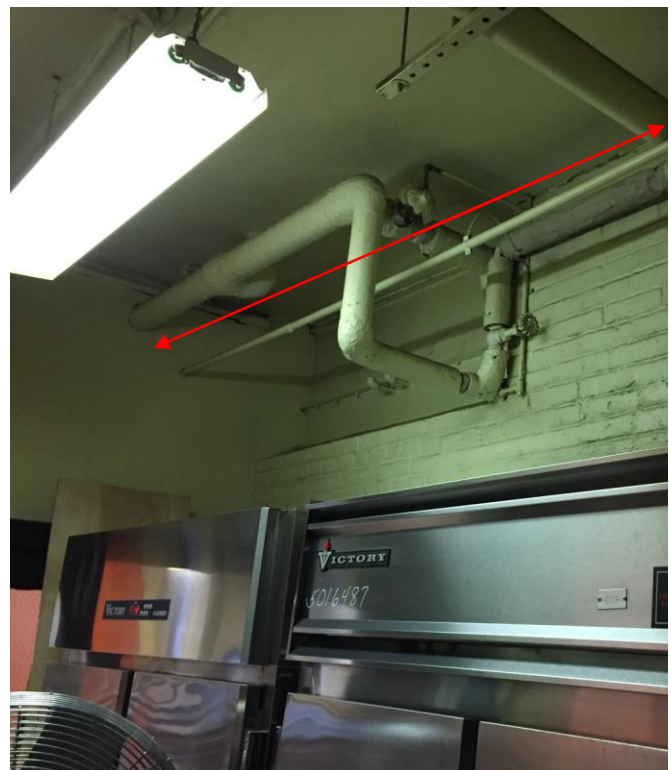
Kitchen Area – Adjacent Hallway above 2 Small Freezers
Remove 13 LF of damaged ACPI and 8 ACPFs (laterals above freezers) - Minor Project
