School District of Philadelphia
Office of Environmental Management Services
440 North Broad St.
Philadelphia, PA 19030

Originally Requested by: Durelle Holmes

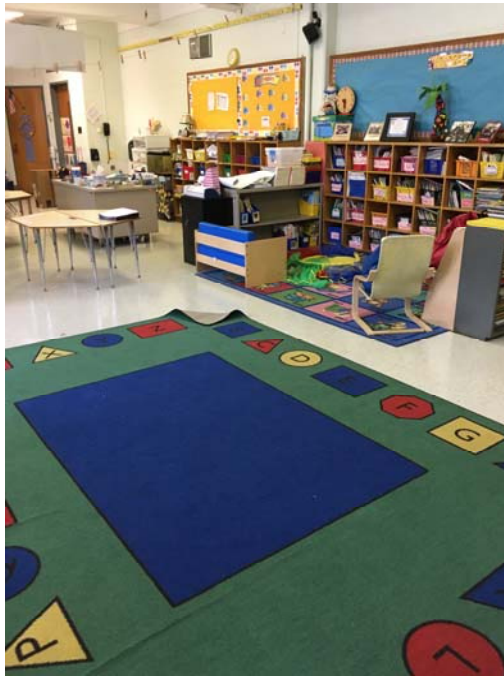
Photo 1 – Kindergarten Room 1

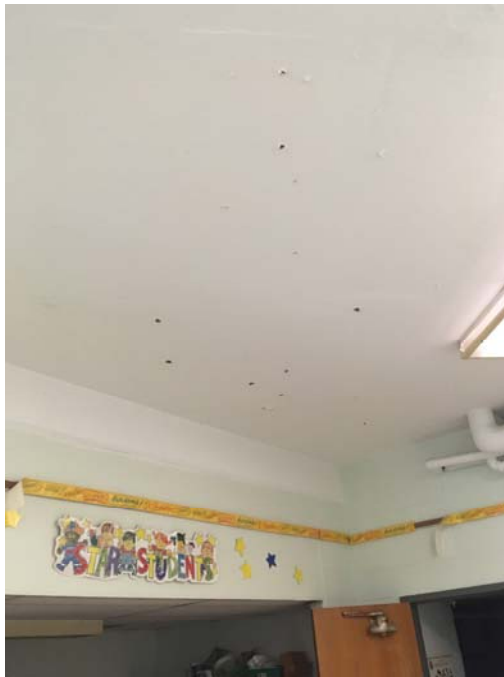
Photo 2 – Kindergarten Room 1

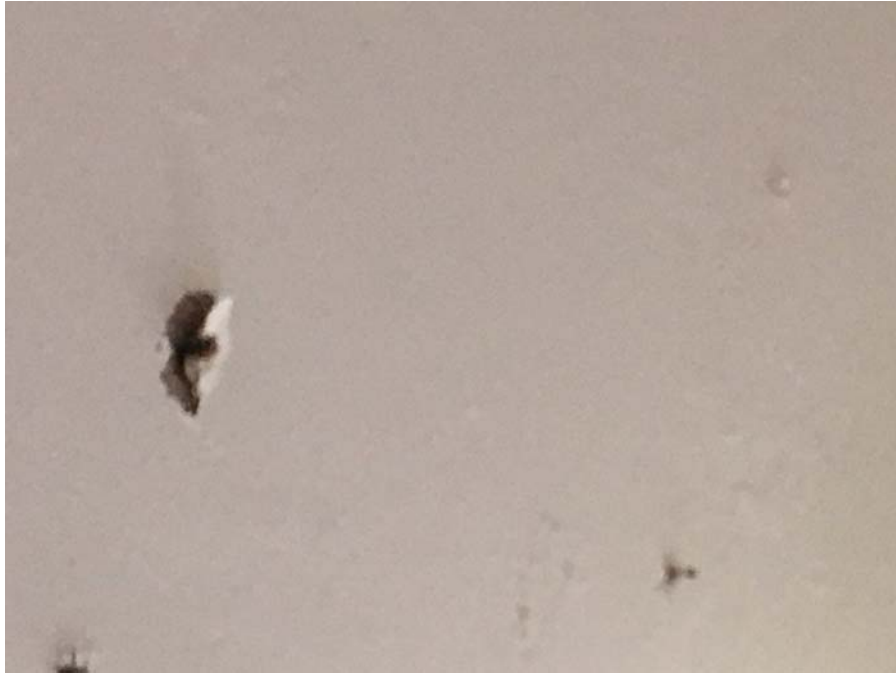
Photo 3 – Kindergarten Room 1
Small sections of spalling concrete ceiling were observed on the ceiling.

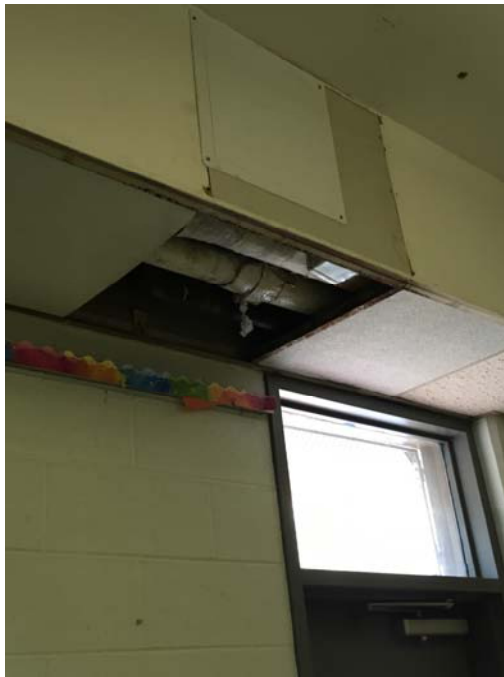
Photo 4 – Kindergarten Room 1
A missing ceiling tile and condensate was dripping from the ceiling. Wet fiberglass pipe insulation was observed above the suspended ceiling.

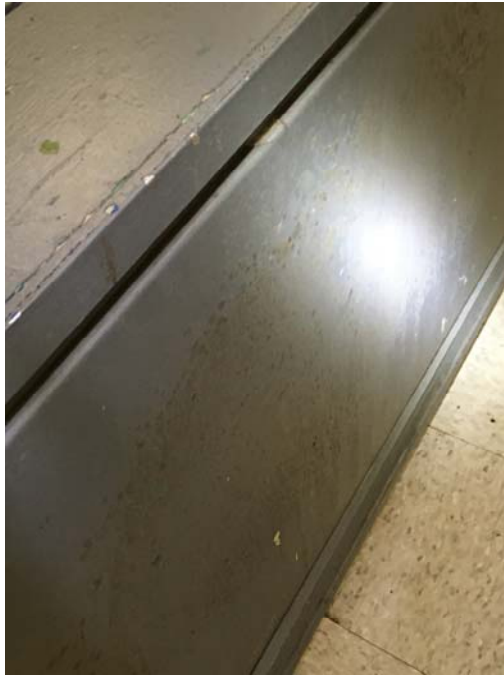
Photo 5 – Kindergarten Room 1
Mold growth was observed on the unit ventilator.

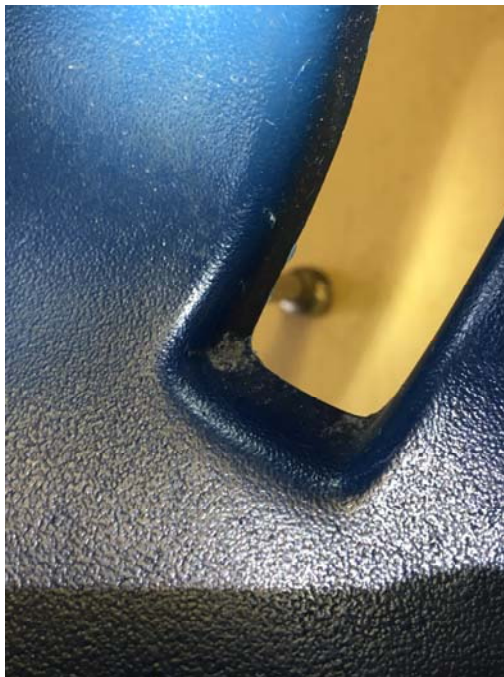
Photo 6 – Kindergarten Room 1
Mold growth was observed on some of the plastic chairs.

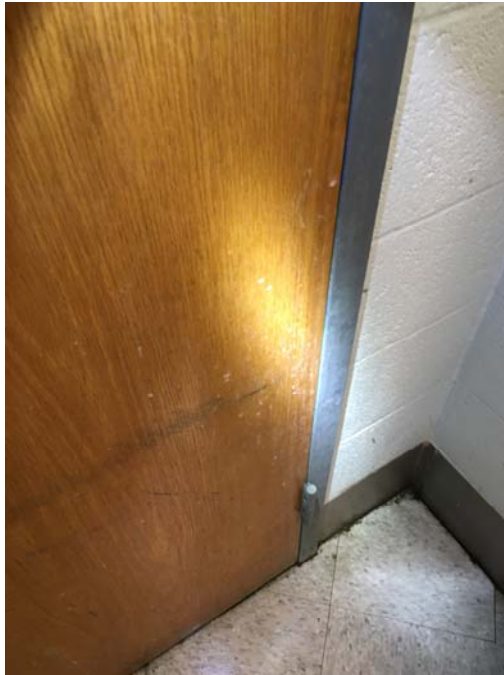
Photo 7 – Kindergarten Room 1
Mold growth was observed on the wooden door and metal frame.

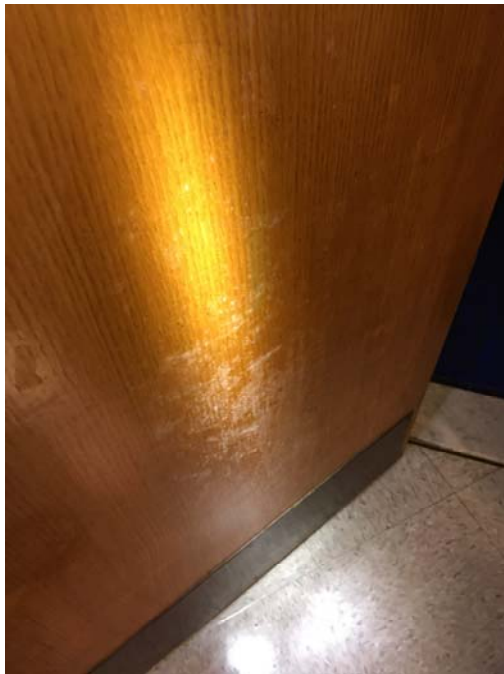
Photo 8 – Kindergarten Room 1
Mold growth was observed on the wooden door and metal frame.

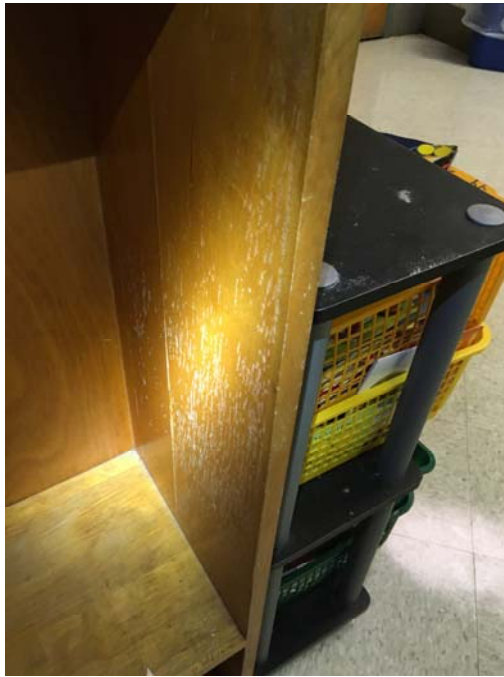
Photo 9 – Kindergarten Room 1
Mold growth was observed on the wooden built-in cabinetry and coat cubby.

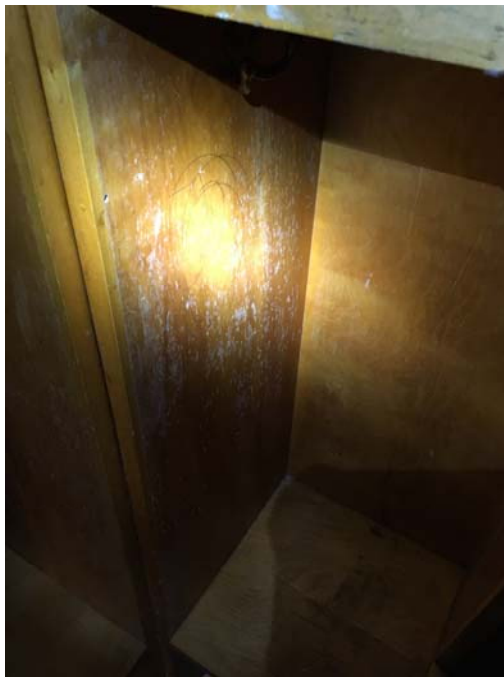
Photo 10 – Kindergarten Room 1
Mold growth was observed on the wooden built-in cabinetry and coat cubby.

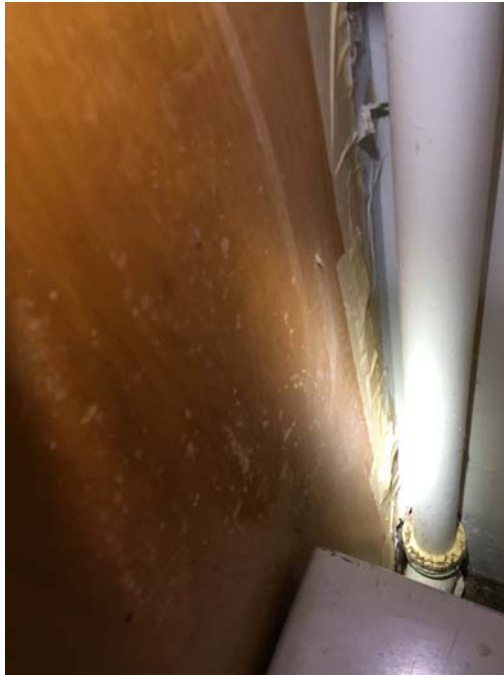
Photo 11– Kindergarten Room 1
Mold growth was observed on the wooden built-in cabinetry and coat cubby.

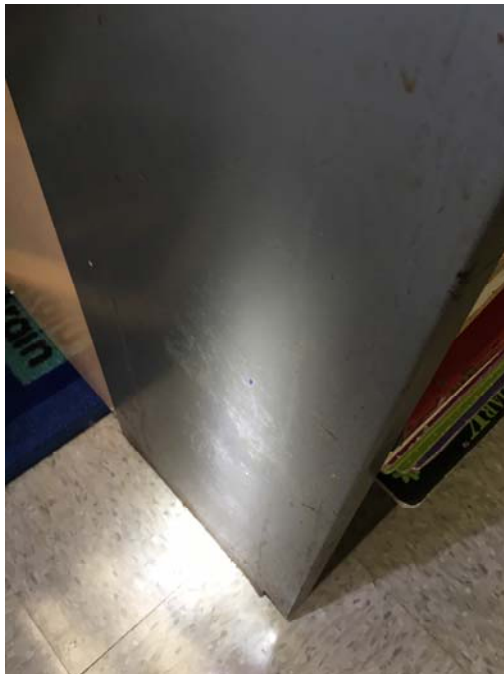
Photo 12 – Kindergarten Room 1
Mold growth was observed on the metal storage cabinet.

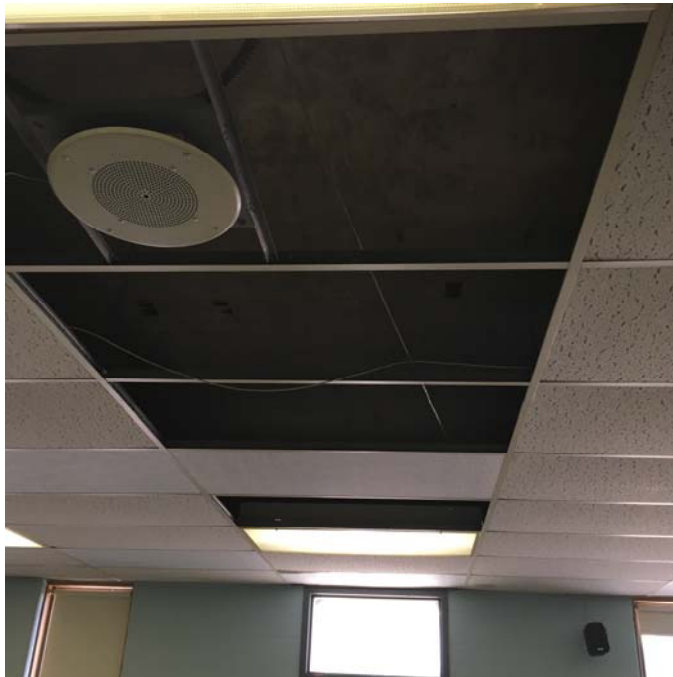
Photo 13 – Kindergarten Room 2
Missing ceiling tiles were observed.

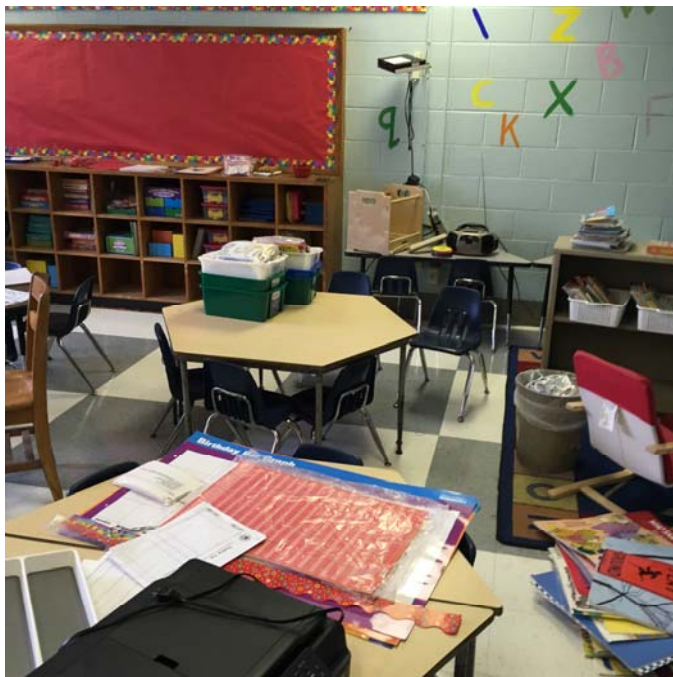
Photo 14 – Kindergarten Room 2

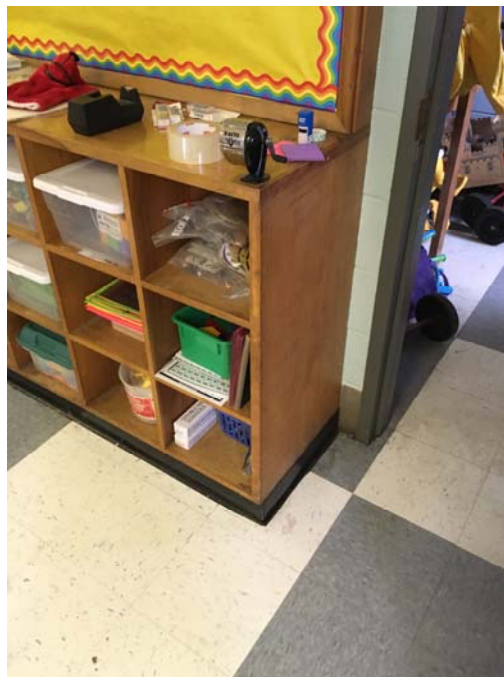
Photo 16 – Kindergarten Room 2

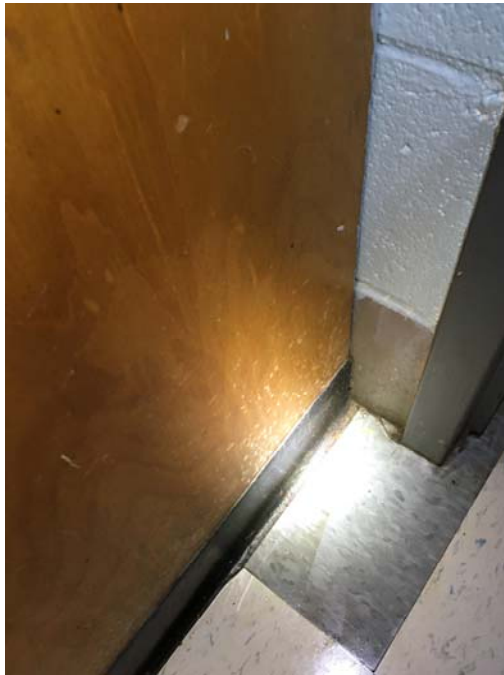
Photo 17 – Kindergarten Room 2
Mold growth was observed on the built-in wooden cabinetry and coat cubby.

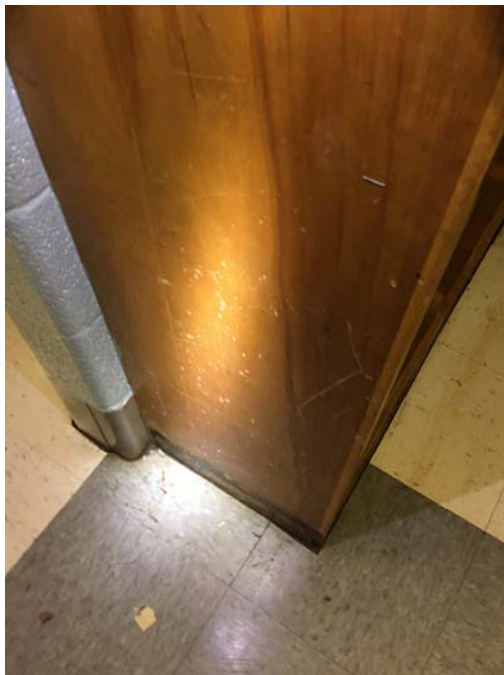
Photo 18 – Kindergarten Room 2
Mold growth was observed on the built-in wooden cabinetry and coat cubby.

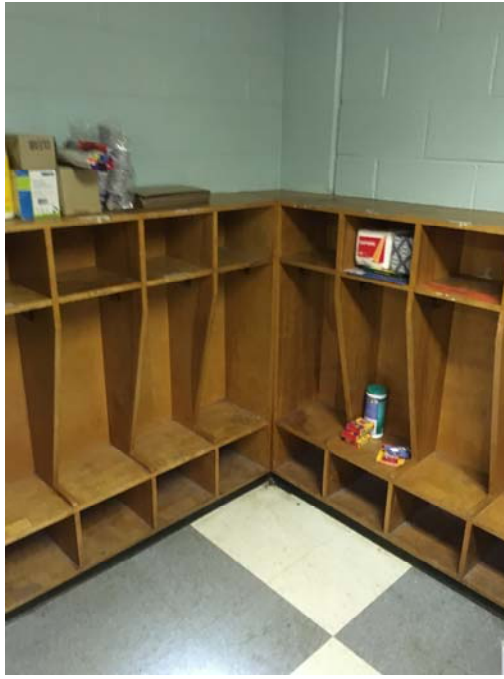
Photo 19 – Kindergarten Room 2
Mold growth was observed on the built-in wooden cabinetry and coat cubby.

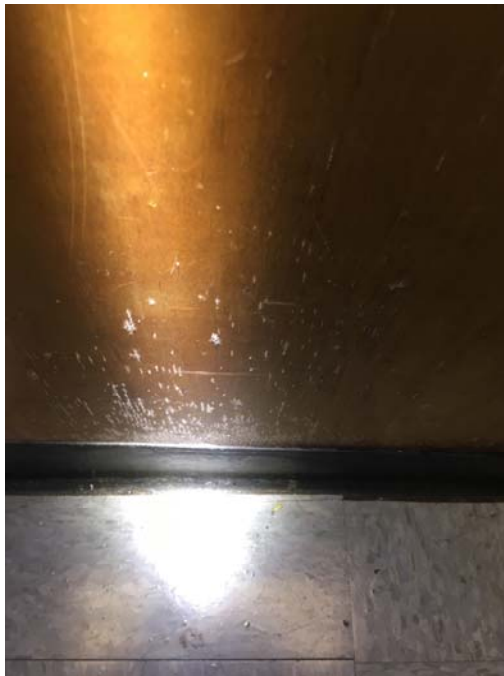
Photo 20 – Kindergarten Room 2
Mold growth was observed on the built-in wooden cabinetry and coat cubby.

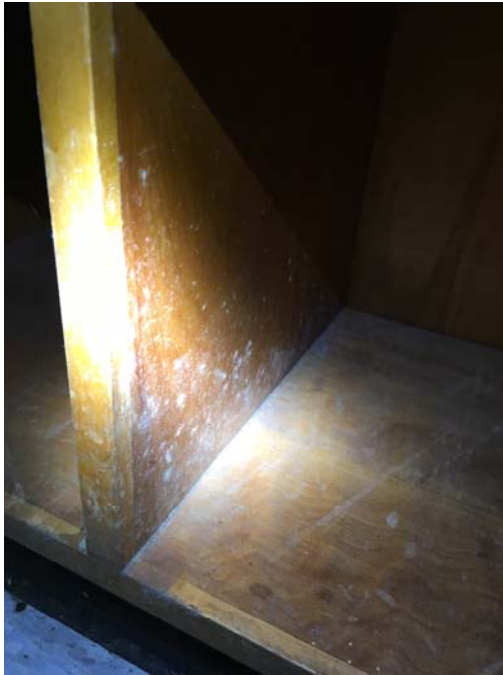
Photo 21 – Kindergarten Room 2
Mold growth was observed on the built-in wooden cabinetry and coat cubby.

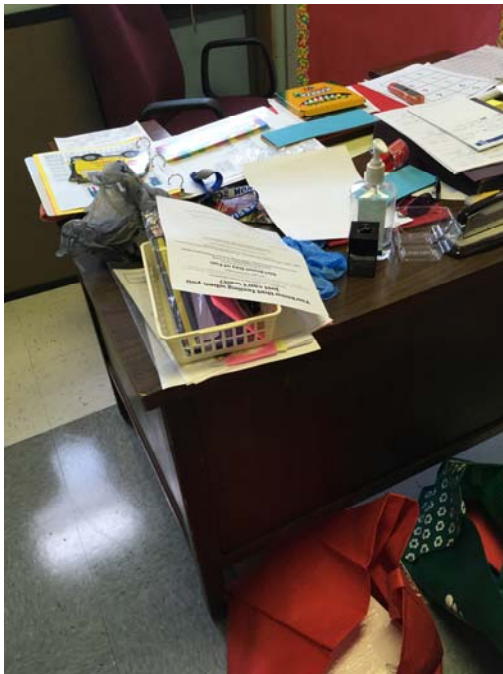
Photo 22 – Kindergarten Room 2
Mold growth was observed on the teacher's desk.

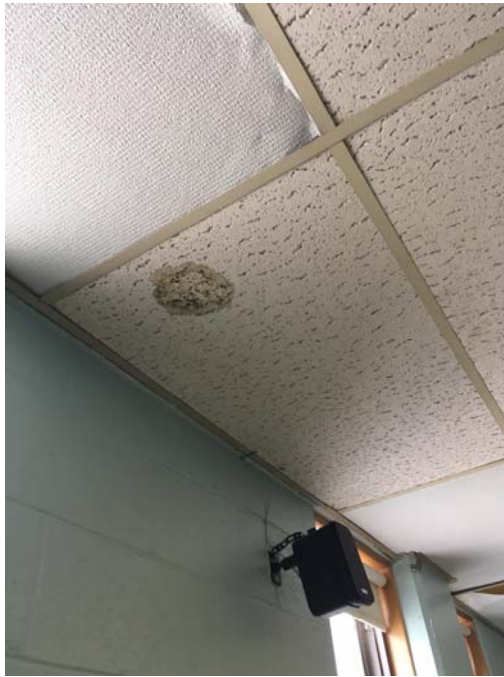
Photo 23 – Kindergarten Room 2
Mold growth was observed on a ceiling tile.

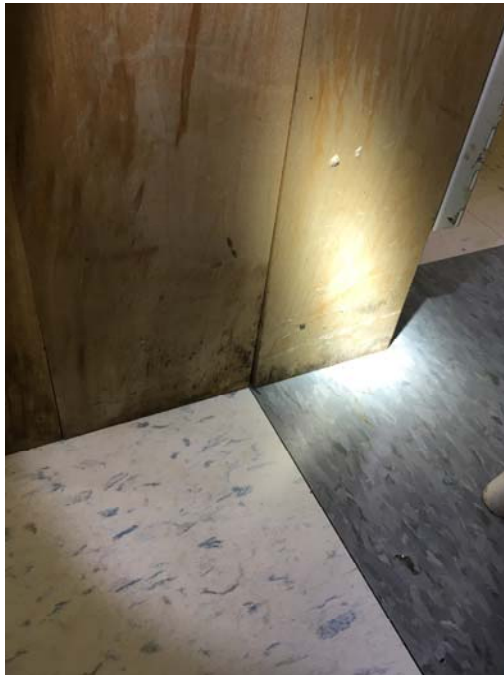
Photo 24 – Kindergarten Room 2
Mold growth was observed on cabinetry.

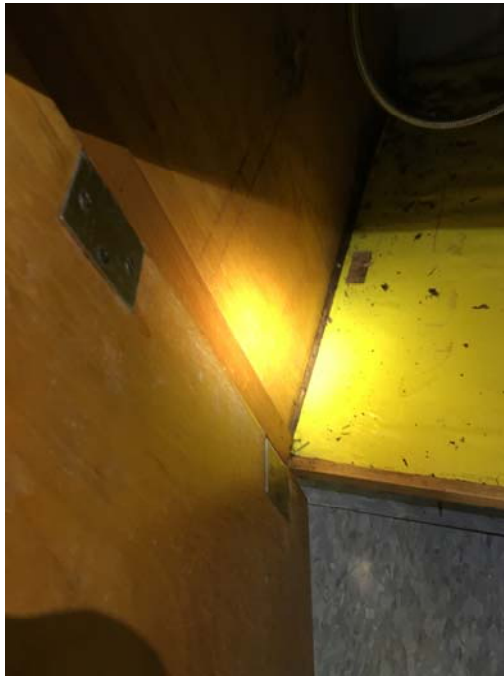
Photo 25 – Kindergarten Room 2
Mold growth was observed on the sink cabinet.

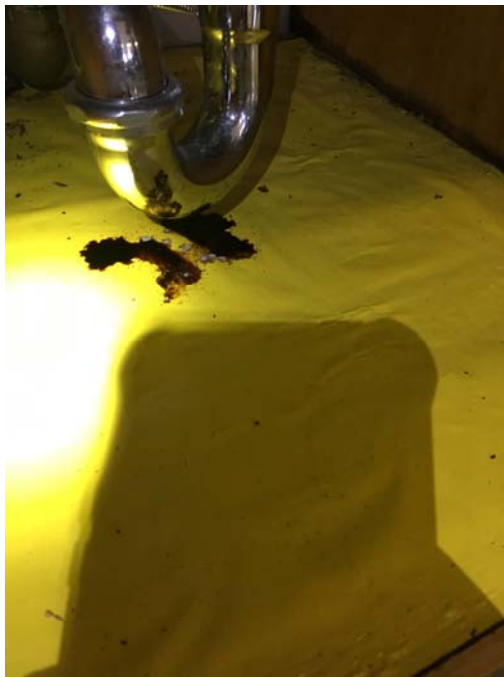
Photo 26 – Kindergarten Room 2
A leak was observed under the sink.

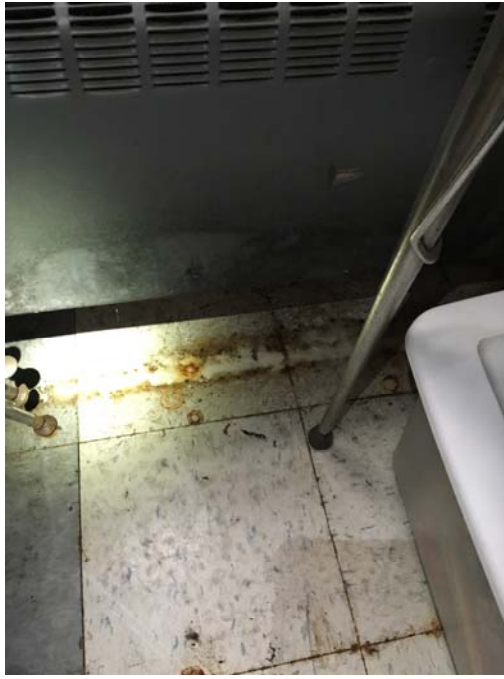
Photo 27 – Kindergarten Room 2 Closet

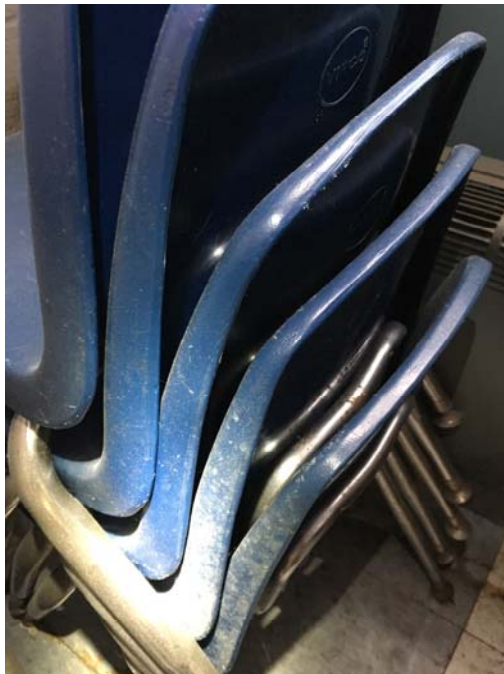
Photo 28 – Kindergarten Room 2 Closet

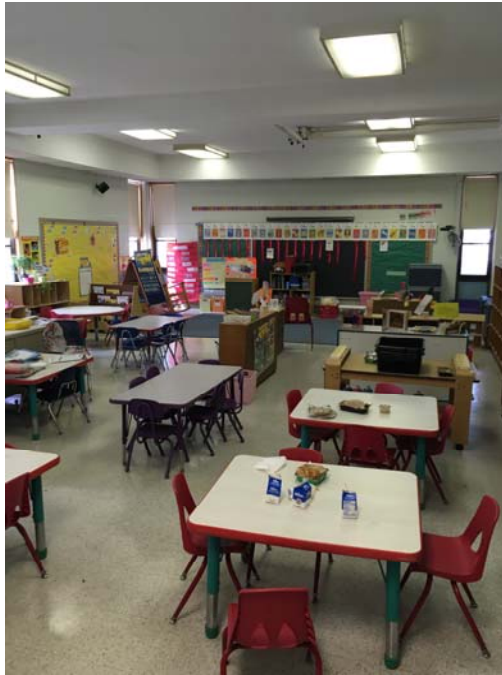
Photo 29 – Kindergarten Room 3

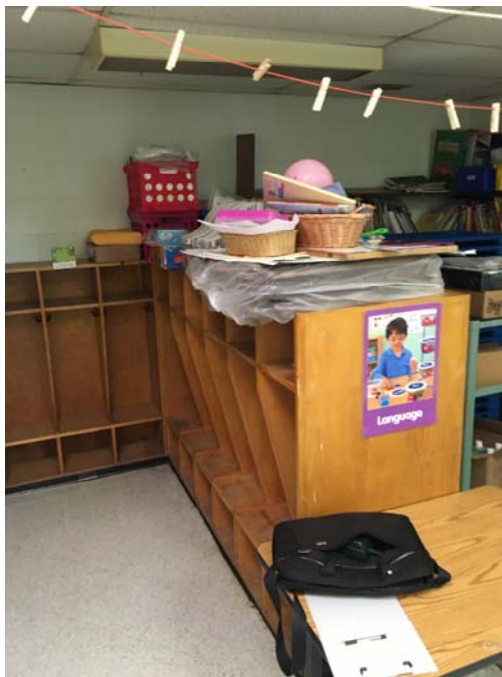
Photo 30 – Kindergarten Room 3

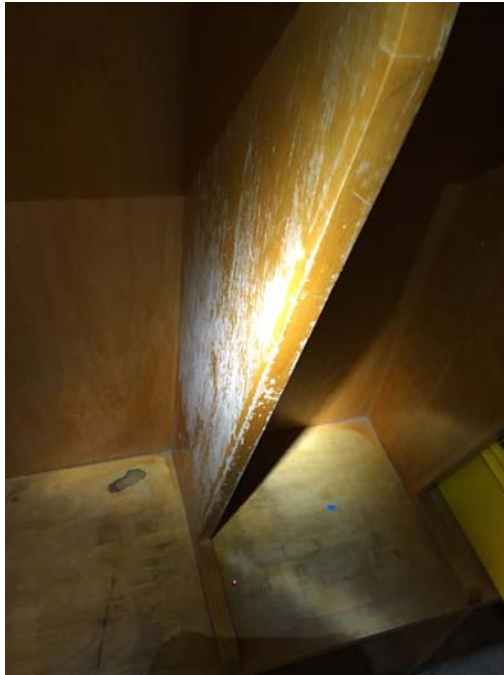
Photo 31 – Kindergarten Room 3
Mold growth was observed on the wooden built-in cabinetry and coat cubby.

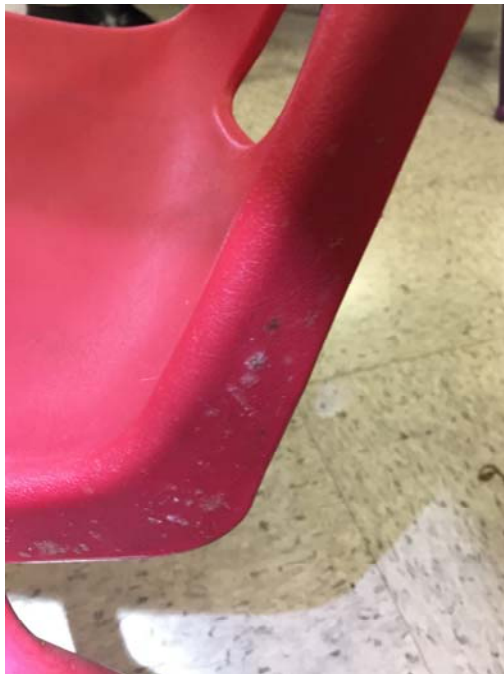
Photo 32 – Kindergarten Room 3
Mold growth was observed on the plastic chairs.

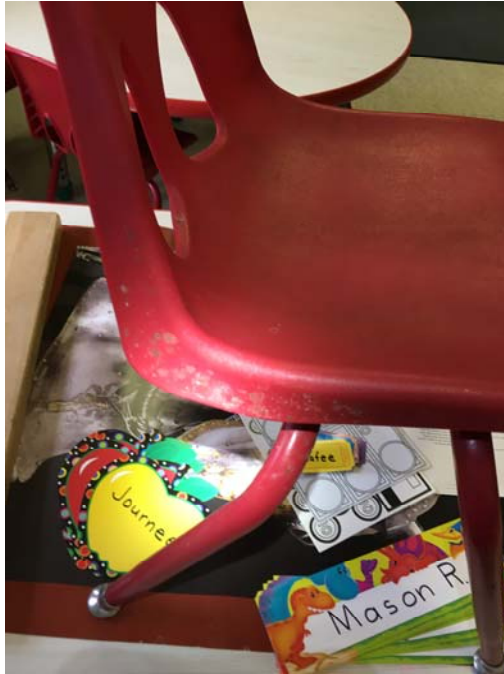
Photo 33 – Kindergarten Room 3
Mold growth was observed on the plastic chairs.

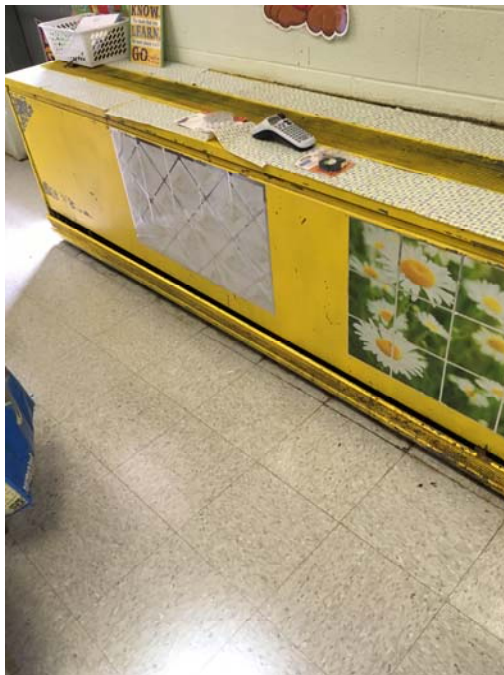
Photo 34 – Kindergarten Room 3
The return air tray was not seated properly and no air filters were observed inside this unit.
