Date Inspected:
12/08/2016

Asbestos Design Data Collection (DDC)

Name of Building: Franklin Learning Center

Address: 616 N 15th St. Philadelphia, PA 19130

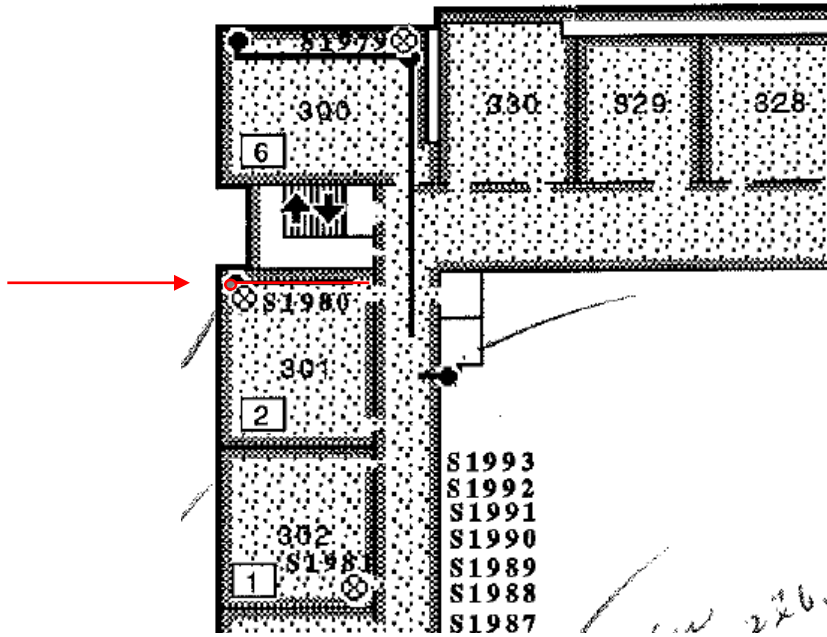
301 – Classroom 301

Remove 37 LF of ACPI and 1 ACPF (riser and lateral) to allow for plaster repairs - Minor Project

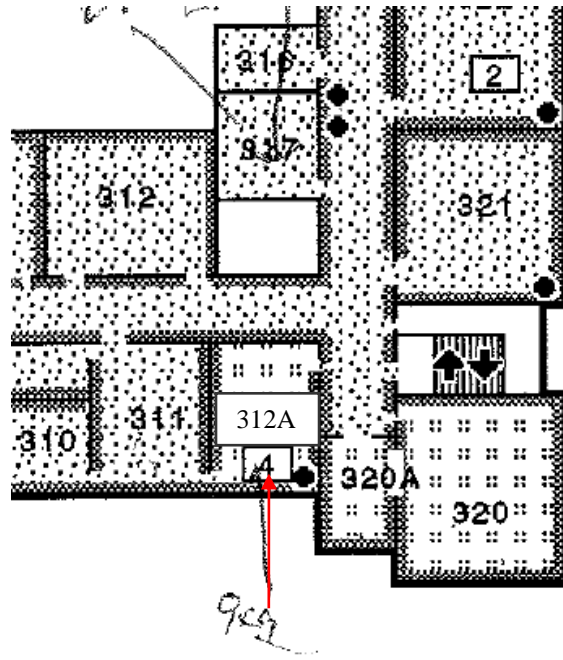
312 – Office 312A

Remove 300 SF of 9"x9" and 12"x12" floor tile with approximately 50 SF of damage – Non-Friable Project

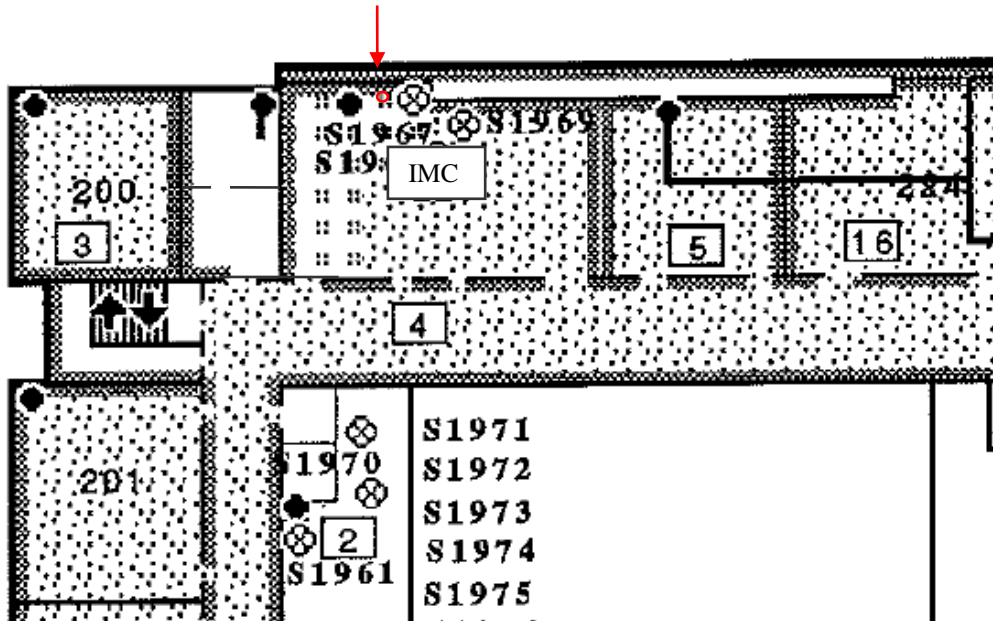
IMC 221

Remove 7 LF of damaged ACPI (riser beside left hand window) - Minor Project
Outer lagging is ripped, torn, repaired with scotch tape - exposed end at bottom

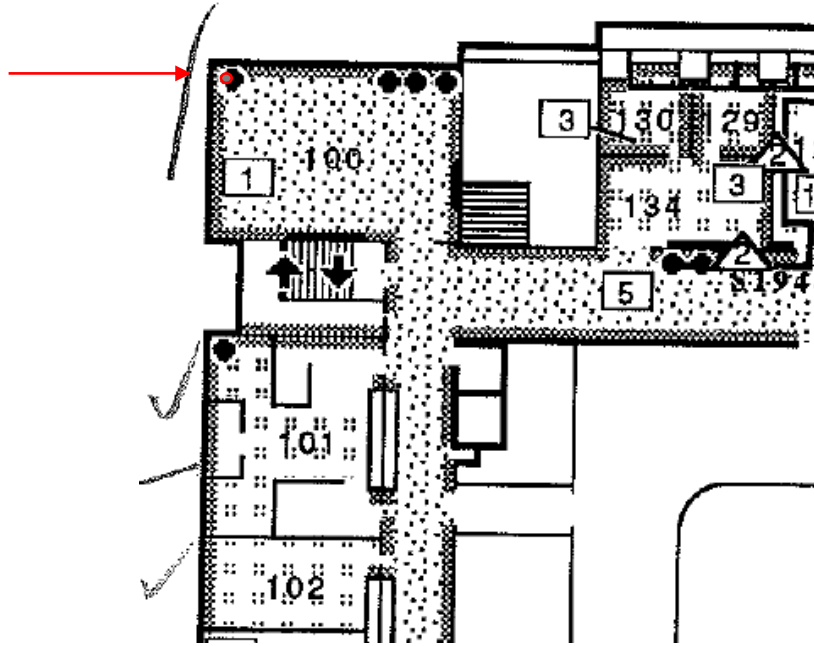
100 – Classroom 100

Remove 14 LF of ACPI (riser) to allow for plaster repairs - Minor Project

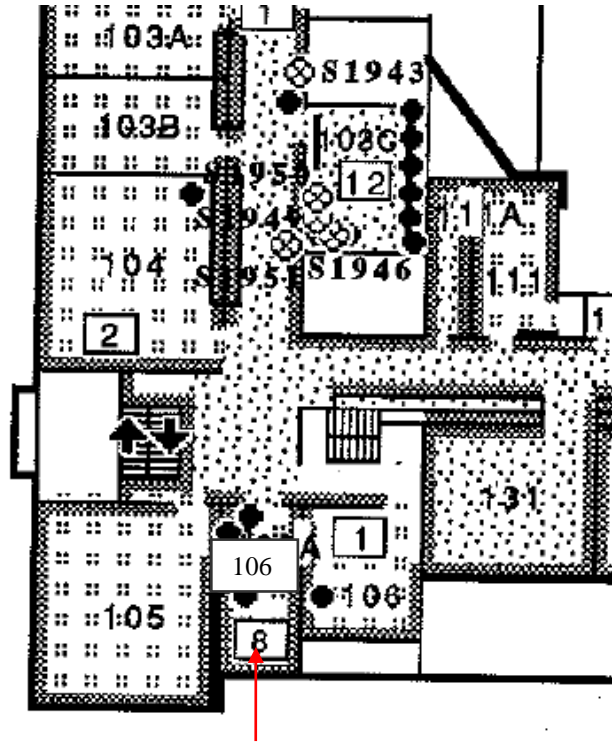
106 – IT MDF Room 106

Remove 16 LF of stained FGPI and 2 ACPFs to allow for plaster repairs - Incidental Project

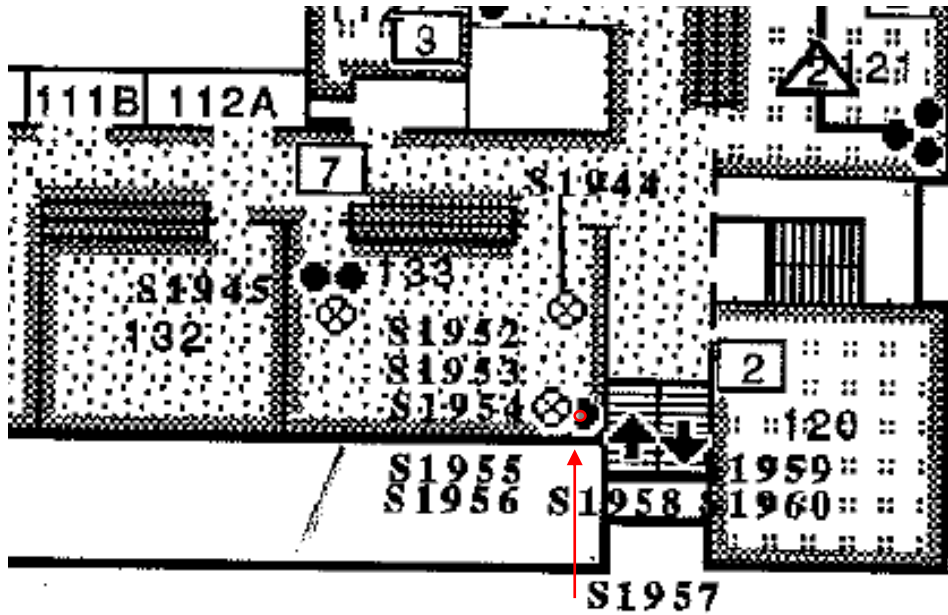
133 – Music Classroom 133
Remove 14 LF of damaged ACPI (riser beside left hand rear corner) - Minor Project
Outer lagging is ripped and torn

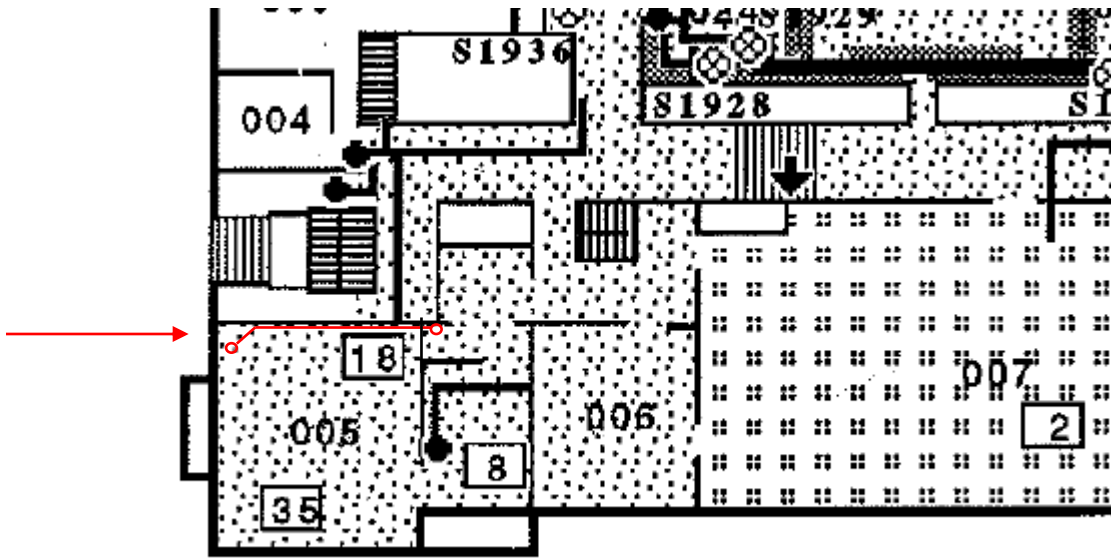
005 – Girl's Locker Room and Laundry Area

Remove 32 LF of damaged ACPI and 5 ACPFs (riser and lateral) - Minor Project

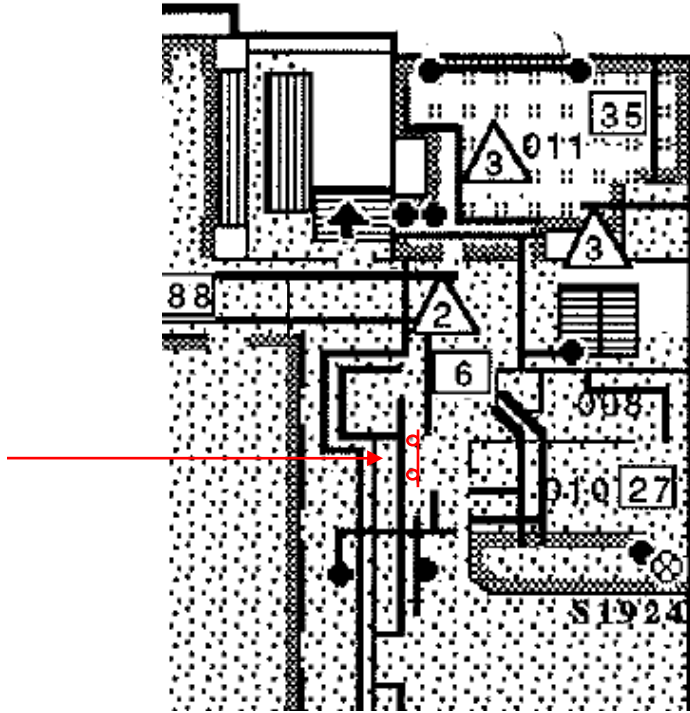
Kitchen Area – Adjacent Hallway above 2 Small Freezers
Remove 13 LF of damaged ACPI and 8 ACPFs (laterals above freezers) - Minor Project
